ON-VEHICLE INSPECTION

1. INSPECT REFRIGERANT VOLUME

2. INSPECT REFRIGERANT PRESSURE WITH MANIFOLD GAUGE SET

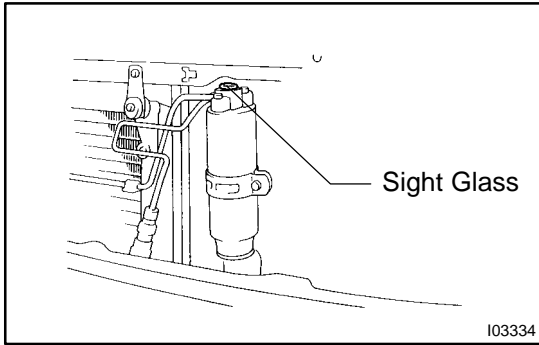
Observe the sight glass on the liquid tube.
