DTC	B0102/11	Short in D Squib Circuit (to Ground)

2003 TOYOTA TACOMA (RM1002U)

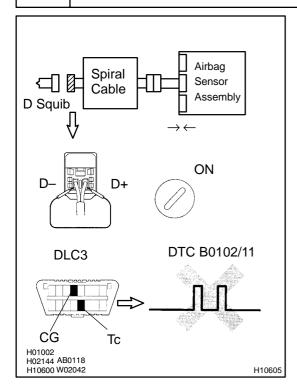
Check airbag sensor assembly.

- (a) Connect the connector to the airbag sensor assembly.
- (b) Using a service wire, connect D+ and D- of the connector (on the spiral cable side) between the spiral cable and the steering wheel pad.
- (c) Connect negative (–) terminal cable to the battery, and wait at least for 2 seconds.

- (a) Turn the ignition switch to ON, and wait at least for 20 seconds.
- (b) Clear the DTC stored in memory (See step 5 on page DI-588).
- (c) Turn the ignition switch to LOCK, and wait at least for 20 seconds.
- (d) Turn the ignition switch to ON, and wait at least for 20 seconds.
- (e) Check the DTC (See page DI-588).

DTC B0102/11 is not output.

Replace airbag sensor assembly.

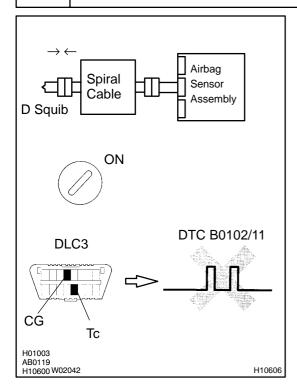
4 Check D squib.

- (a) Turn the ignition switch to LOCK.
- (b) Disconnect negative (–) terminal cable from the battery, and wait at least for 90 seconds.
- (c) Connect the steering wheel pad connector.
- (d) Connect negative (–) terminal cable to the battery, and wait at least for 2 seconds.

- (a) Turn the ignition switch to ON, and wait at least for 20 seconds.
- (b) Clear the DTC stored in memory (See step 5 on page DI-588).
- (c) Turn the ignition switch to LOCK, and wait at least for 20 seconds.
- (d) Turn the ignition switch to ON, and wait at least for 20 seconds
- (e) Check the DTC (See page DI-588).

DTC B0102/11 is not output.

NG Replace steering wheel pad.
