| DTC | B0135/73 | Short in P/T Squib (LH) Circuit |

2003 TOYOTA TACOMA (RM1002U)

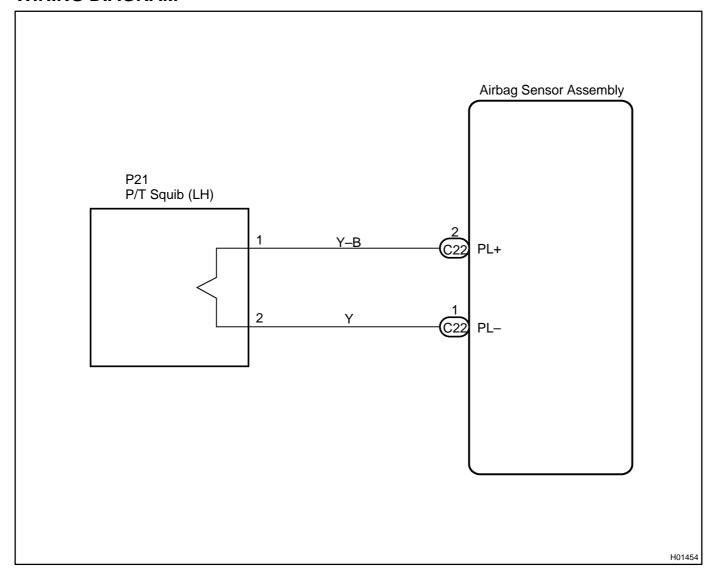
WIRING DIAGRAM

The P/T squib (LH) circuit consists of the airbag sensor assembly and seat belt pretensioner (LH). It causes the SRS to deploy when the SRS deployment conditions are satisfied. For details of the function of each component, see OPERATION on page RS-2. DTC B0135/73 is recorded when a short is detected in the P/T squib (LH) circuit.

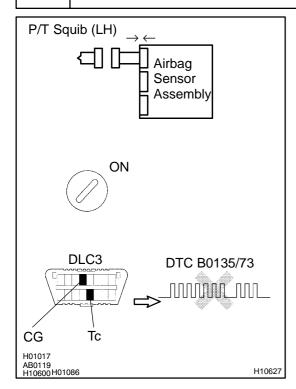
Check airbag sensor assembly.

PREPARATION:

- (a) Connect the connector to the airbag sensor assembly.
- (b) Connect negative (–) terminal cable to the battery, and wait at least for 2 seconds.

CHECK:

- (a) Turn ignition switch to ON and wait at least for 20 seconds.
- (b) Clear DTC stored in memory. (See page DI-588)
- (c) Turn ignition switch to LOCK, and wait at least for 20 seconds.
- (d) Turn ignition switch to ON, and wait at least for 20 seconds.
- (e) Check DTC. (See page DI-588)

DTC B0135/73 is not output.

Replace airbag sensor assembly.

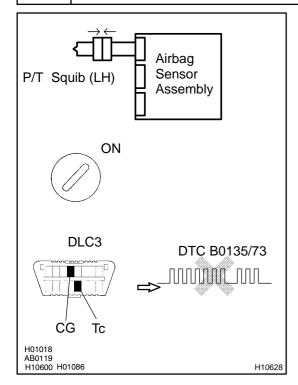
4 Check P/T squib (LH).

PREPARATION:

- (a) Turn ignition switch to LOCK.
- (b) Disconnect negative (–) terminal cable from the battery, and wait at least for 90 seconds.
- (c) Connect the side airbag assembly (LH) connector.
- (d) Connect negative (–) terminal cable to the battery, and wait at least for 2 seconds.

CHECK:

- (a) Turn ignition switch to LOOK, and wait at least for 20 second.
- (b) Turn ignition switch to ON, and wait at least for 20 seconds.
- (c) Clear DTC stored in memory. (See page DI-588)
- (d) Turn ignition switch to LOCK, and wait at least for 20 seconds.
- (e) Turn ignition switch to ON, and wait at least for 20 seconds.
- (f) Check DTC. (See page DI-588)

DTC B0135/73 is not output.

Replace seat belt pretensioner (LH).
