DI55I-02

DTC B0136/74 Open in P/T Squib (LH) Circuit

2003 TOYOTA TACOMA (RM1002U)

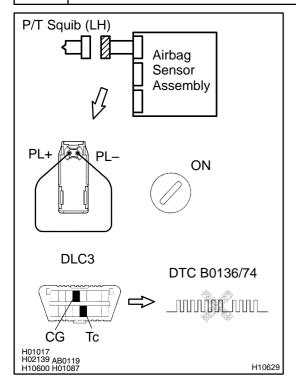
3 Check airbag sensor assembly.

- (a) Connect the connector to the airbag sensor assembly.
- (b) Using a service wire, connect PL+ and PL- of the connector (on the seat belt pretensioner side) between the seat belt pretensioner (LH) and the airbag sensor assembly.
- (c) Connect negative (–) terminal cable to the battery, and wait at least for 2 seconds.

- (a) Turn ignition switch to ON and wait at least for 20 seconds.
- (b) Clear DTC stored in memory. (See page DI-588)
- (c) Turn ignition switch to LOCK, and wait at least for 20 seconds.
- (d) Turn ignition switch to ON, and wait at least for 20 seconds.
- (e) Check DTC. (See page DI-588)

DTC B0136/74 is not output.

Replace airbag sensor assembly.

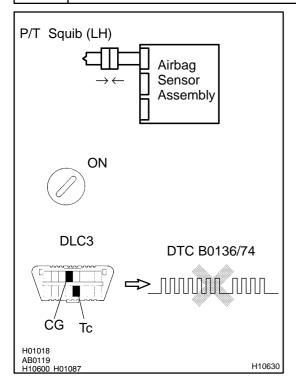
4 Check P/T squib (LH).

- (a) Turn ignition switch to LOCK.
- (b) Disconnect negative (–) terminal cable from the battery, and wait at least for 90 seconds.
- (c) Connect the seat belt pretensioner (LH) connector.
- (d) Connect negative (–) terminal cable to the battery, and wait at least for 2 seconds.

- (a) Turn ignition switch to ON, and wait at least for 20 seconds.
- (b) Clear DTC stored in memory. (See page DI-588)
- (c) Turn ignition switch to LOCK, and wait at least for 20 seconds.
- (d) Turn ignition switch to ON, and wait at least for 20 seconds.
- (e) Check DTC. (See page DI-588)

DTC B0136/74 is not output.

Replace seat belt pretensioner (LH).
