DTC B0138/72 Short in P/T Squib (LH) Circuit (to B+)

2003 TOYOTA TACOMA (RM1002U)

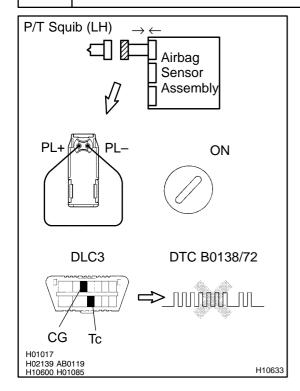
## Check airbag sensor assembly.

- (a) Connect the connector to the airbag sensor assembly.
- (b) Using a service wire, connect PL+ and PL- of the connector (on the seat belt pretensioner side) between the seat belt pretensioner (LH) and the airbag sensor assembly.
- (c) Connect negative (–) terminal cable to the battery, and wait at least for 2 seconds.

- (a) Turn ignition switch to ON and wait at least for 20 seconds.
- (b) Clear DTC stored in memory. (See step 5 on page DI-588)
- (c) Turn ignition switch to LOCK, and wait at least for 20 seconds.
- (d) Turn ignition switch to ON, and wait at least for 20 seconds.
- (e) Check DTC. (See page DI-588)

## DTC B0138/72 is not output.

Replace airbag sensor assembly.

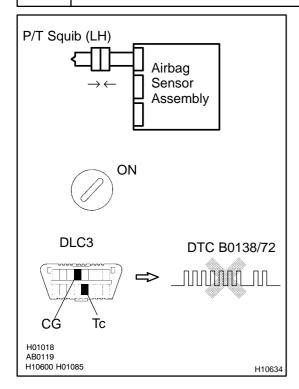
# 4 Check P/T squib (LH).

- (a) Turn ignition switch to LOCK.
- (b) Disconnect negative (–) terminal cable from the battery, and wait at least for 90 seconds.
- (c) Connect the seat belt pretensioner (LH) connector.
- (d) Connect negative (–) terminal cable to the battery, and wait at least for 2 seconds.

- (a) Turn ignition switch to ON, and wait at least for 20 seconds.
- (b) Clear DTC stored in memory. (See step 5 on page DI-588)
- (c) Turn ignition switch to LOCK, and wait at least for 20 seconds.
- (d) Turn ignition switch to ON, and wait at least for 20 seconds.
- (e) Check DTC. (See page DI-588)

## DTC B0138/72 is not output.

Replace seat belt pretensioner (LH).
