DTC	P0335	Crankshaft Position Sensor "A" Circuit Mal- function
-----	-------	---

2001 TOYOTA TACOMA (RM835U)

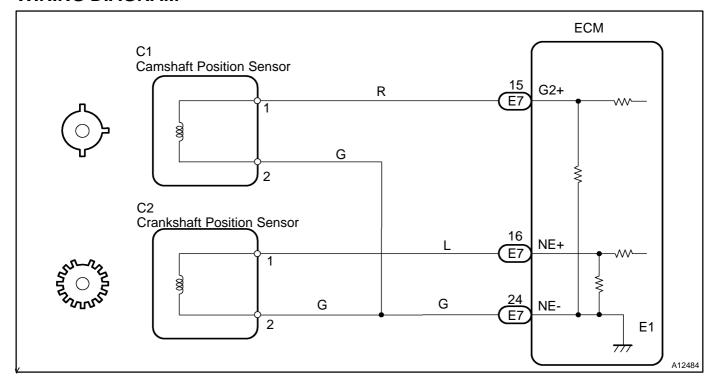
## WIRING DIAGRAM

Crankshaft position sensor (NE signal) consists of and pickup coil.

The NE signal plate has 34 teeth and is mounted on the crankshaft. The NE signal sensor generates 34 signals at every engine revolution. The ECM detects the standard crankshaft angle based on the G signal, and the actual crankshaft angle and the engine speed by the NE signal.

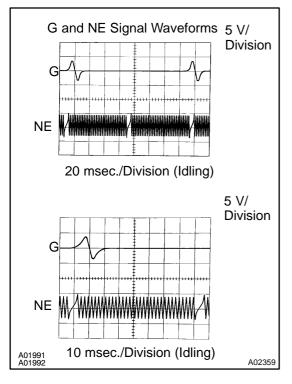
**Reference: INSPECTION USING OSCILLOSCOPE** California Spec.

During cranking or idling, check the waveforms between terminals G2 and NE-, and NE+ and NE- of the ECM connector. HINT:

The correct waveforms are as shown.
