DTC	P0335	Crankshaft Position Sensor "A" Circuit Malfunction
	1 0000

2001 TOYOTA TACOMA (RM835U)

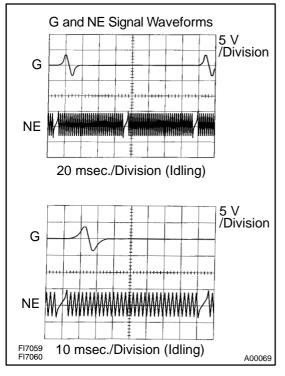
#### Reference: INSPECTION USING OSCILLOSCOPE

During cranking or idling, check the waveform between terminals G2 (California Spec.) or G+ (Except California Spec.) and NE-, and NE+ and NE- of the ECM connector. HINT:

The correct waveforms are as shown.
